Product: OAK4-S

Description: Environmental and Chemical Test

## Test report 25-AZ165

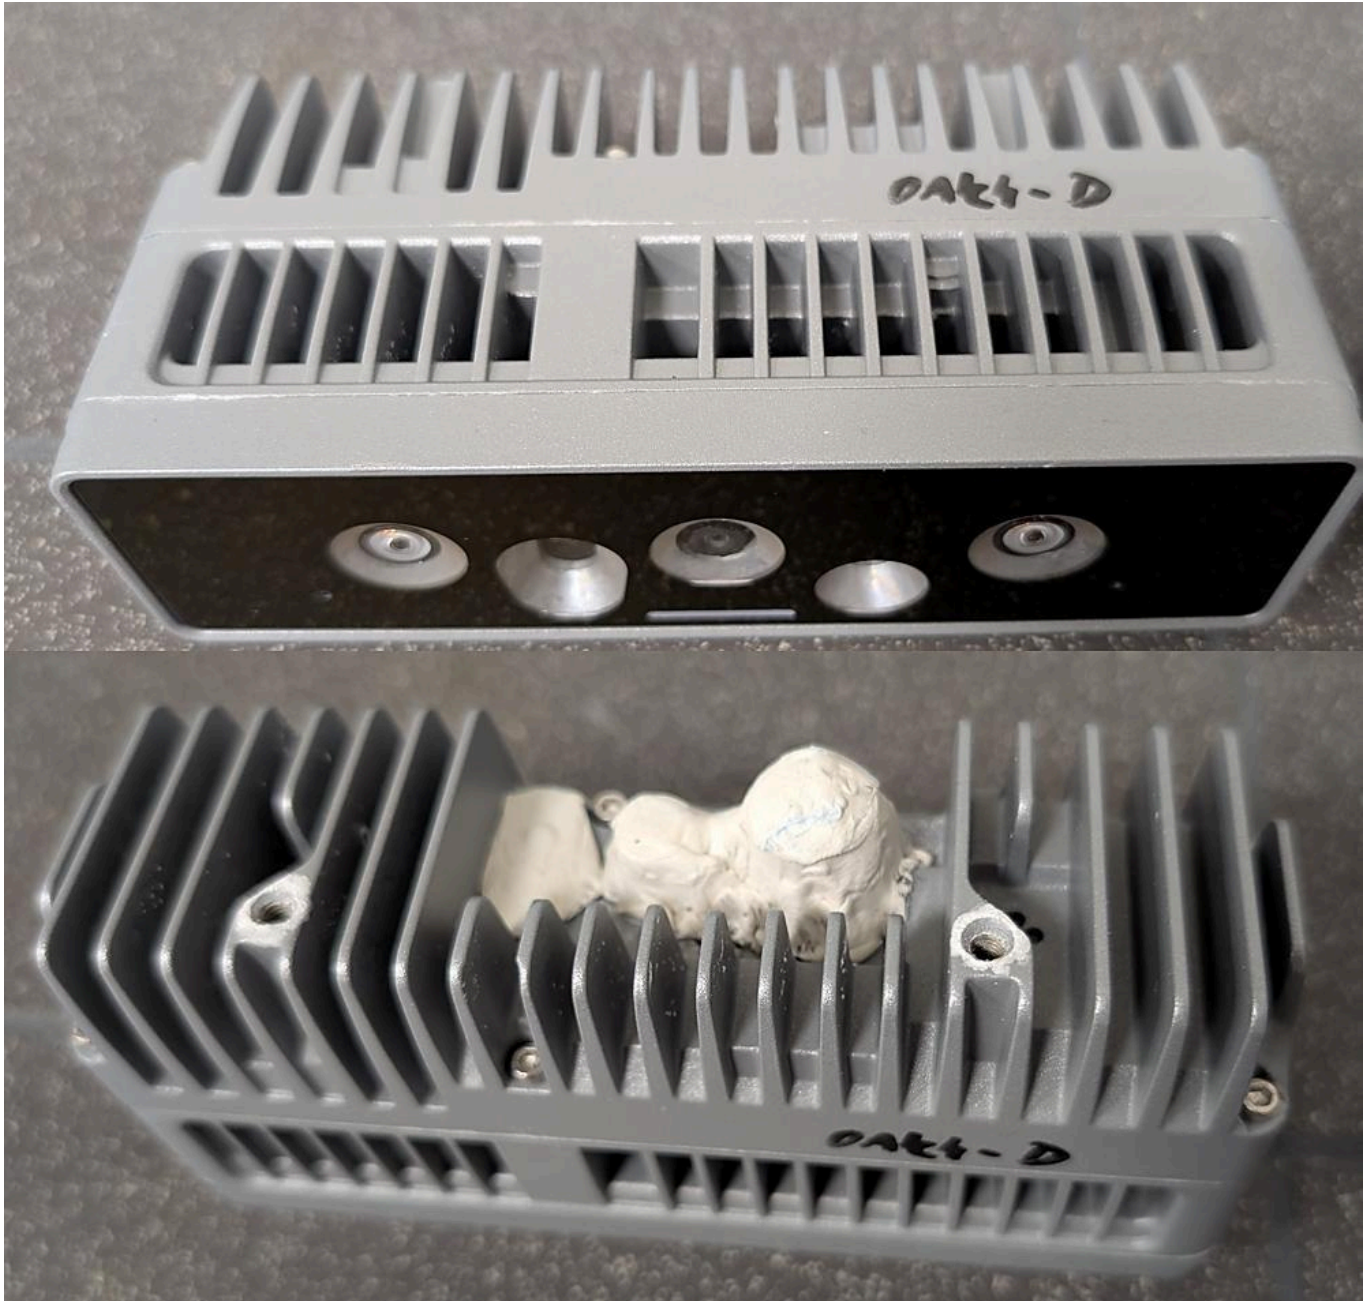
## 7. Samples photo after 24h of salt spray test

| Assessment of surface changes acc. to ČSN EN ISO 4628-1 | | | |
|---|---|---|---|
| OAK4-D | 24h<br>ČSN EN ISO<br>9227 NSS | 0 – without changes | R% 0 (0%) |

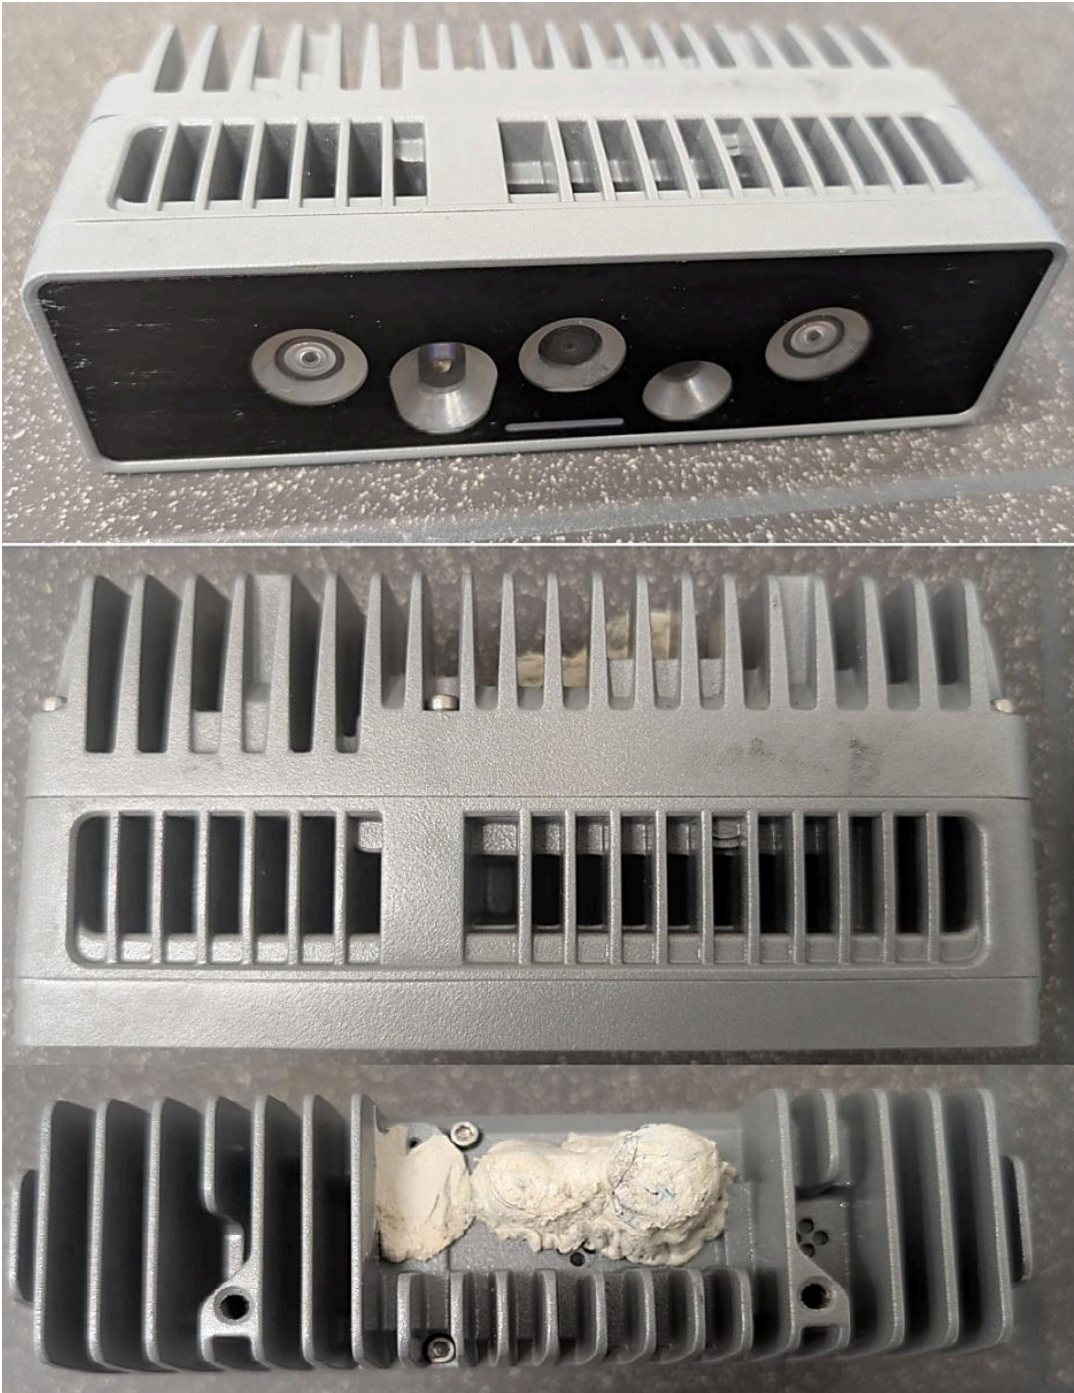
9. Samples photo after chemical resistance test

Damage caused by the chemical test appears to be minimal and is limited to two small areas near the screw head. The blistering most likely resulted from initial mechanical damage caused by the screw during tightening.

The minor imperfections observed have no impact on the overall durability of the surface coating.
