# Robotics Revive Mine in Crisis

## INTRODUCTION

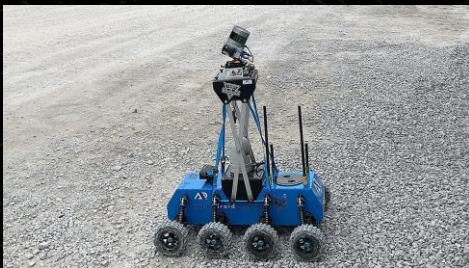
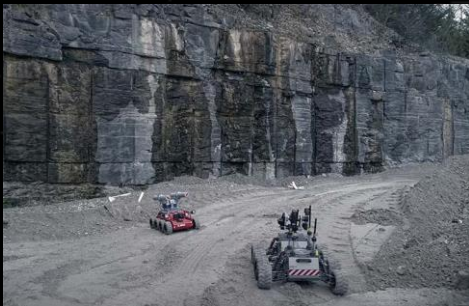
In collaboration with PBE Communications, Rajant, and KAARTA, a solution was engineered using the Explora Series of ground robots. 10 Explora XL robots were fitted with KAARTA LiDAR, Visual Inspection cameras, and Rajant breadcrumb mesh network AC points, building a long network of communications that extended at one point up to 1.7km down into the mine, the deepest remote operation ever achieved.

Several Explora XL robots were fitted with high-powered PTZ cameras and lights to provide visual assessments of the environment, with one being fitted with a camera on a Telescopic arm to see over bunds. A LiDAR system was also fitted, to provide a 3D point cloud of the environment to collect geospatial information.
