# OAK4-S P5 Thermal shock test

ISO 19014 according to IEC 60068-2-14 Test Na

**Date:** 10.6.2025

**Location:** SIQ-Ljubljana, Slovenia

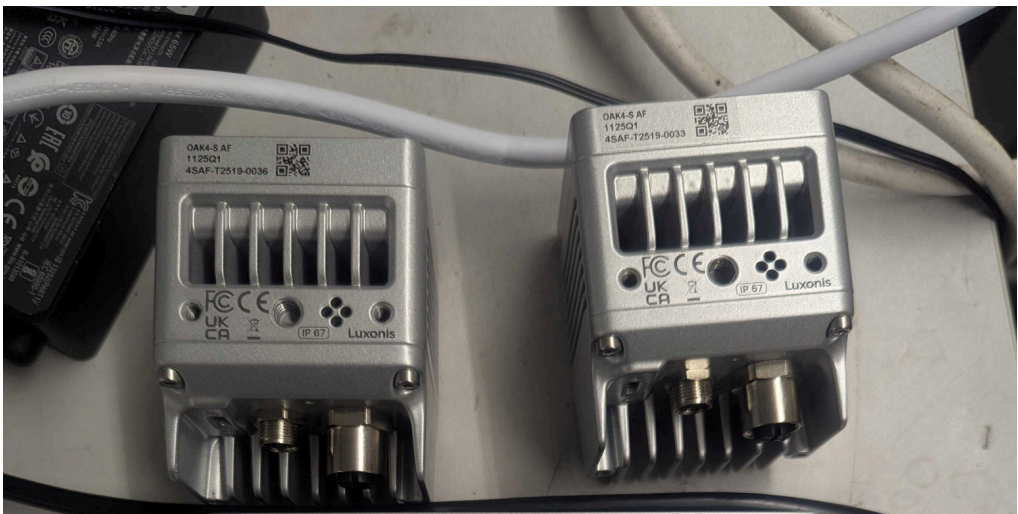
Devices used for the test.

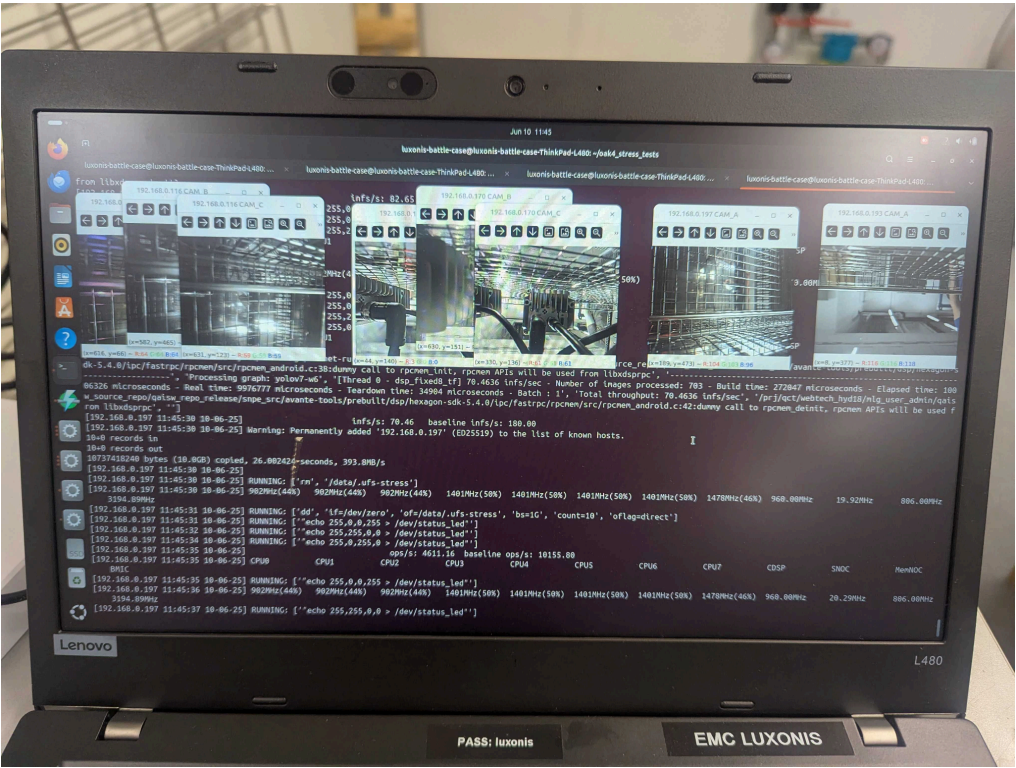
Running the stress test on the device while testing.
